Phase 2 – Sewer System Evaluation Survey Farmington Sewershed

Presentation to Town of Avon Water Pollution Control Authority July 14, 2022

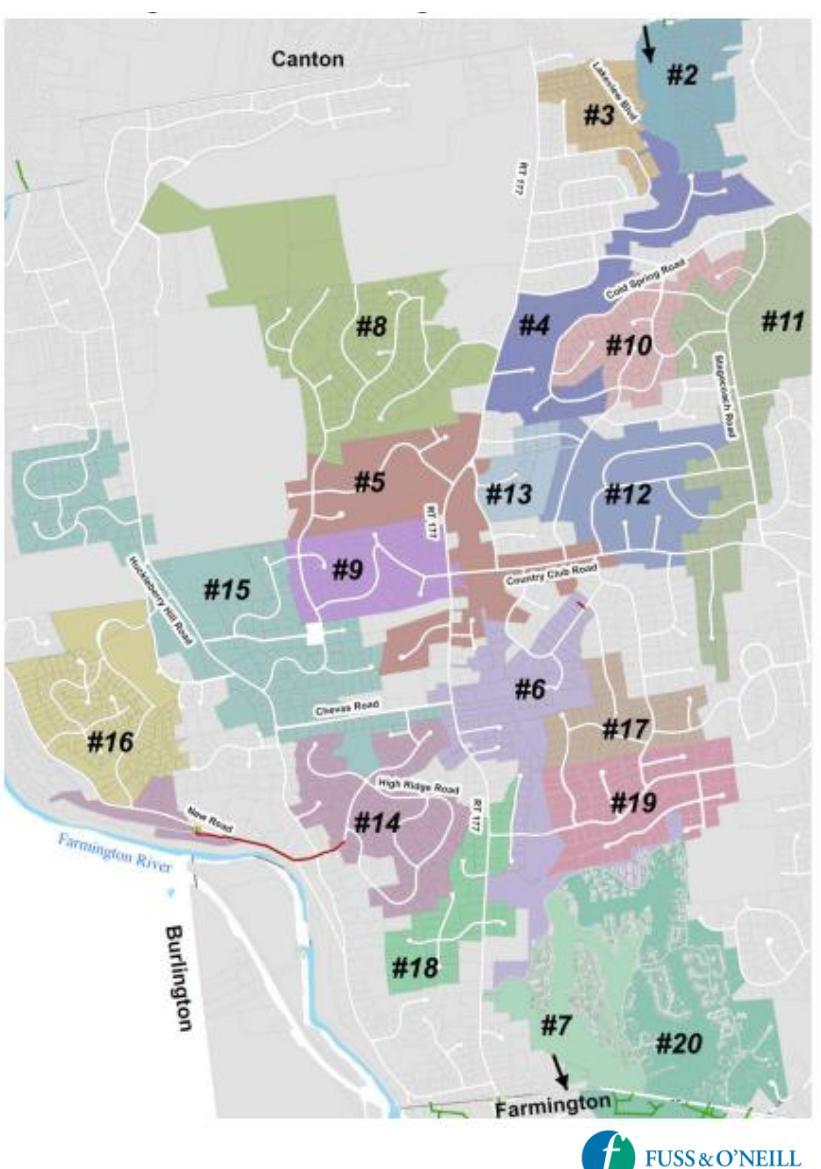
<u>Flow Monitoring</u>

- Divided Sewershed into 20 Meter Basins
- EPA Excessive Infiltration & Inflow Metrics
- 30% of meter basins rated as high in one or both metrics

Manhole Inspection

- Visual Inspection of Manhole Structures for evidence of I&I
- 215 Manholes Inspected (20% of Sewershed)
- 14 Severe Defects, 62 Moderate, 201 Minor

Dye Flow Dilution

- Quantifies Increased Flow between Pipe Segments during Overnight Low Flow, Isolating Problem Areas to be CCTV'd
- 20 miles Investigated (45% of Sewershed)
- 4 Severe Metersheds, 2 Moderate, 3 Minor

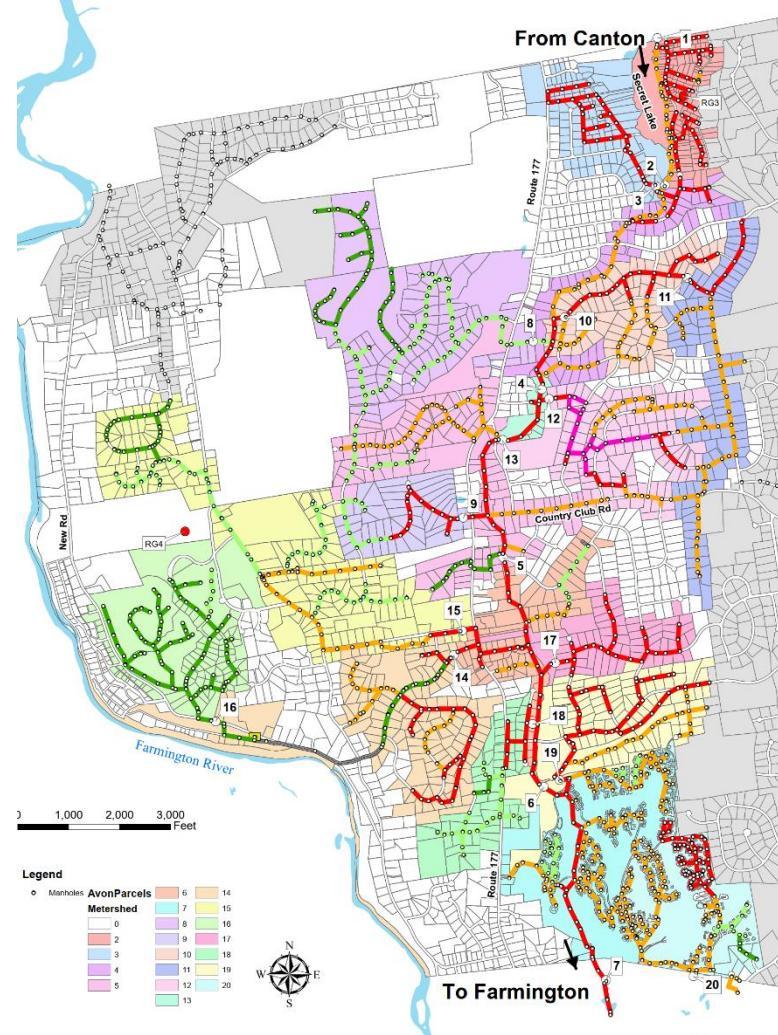
- <u>Smoke Testing Fall 2022</u>
 - Non-toxic, non-staining, non-explosive smoke to find illicit connections
 - 4 Metersheds targeted based on Phase 1 Inflow Metric

- <u>Sewer Rehabilitation General Specifications Winter 2022</u>
- <u>Comprehensive Manhole Inspection Early Spring 2023</u>
 - Visual Inspection of Manhole Structures for evidence of I&I

- 175 Manholes selected based on age of infrastructure and discussion with Town Staff
- Dye Flow Dilution Mid Spring 2023
 - Quantifies Increased Flow between Pipe Segments during Overnight Low Flow, Isolating Problem Areas

- 4 Metersheds Investigated based on Phase 1 Infiltration Metric
- <u>Capacity Analysis of Sanford & Hawley Interceptor Summer 2023</u>
 - 2 Flow Meters for 8 Weeks to make Hydraulic Calculations
